SALT CONTAMINATION OF PRIVATE WELL WATER SUPPLIES

TOWN OF WHITCHURCH — STOUFFVILLE
COMMUNITY OF BALLANTRAE

SALT CONTAMINATION OF PRIVATE
WELL WATER SUPPLIES

JANUARY 1977

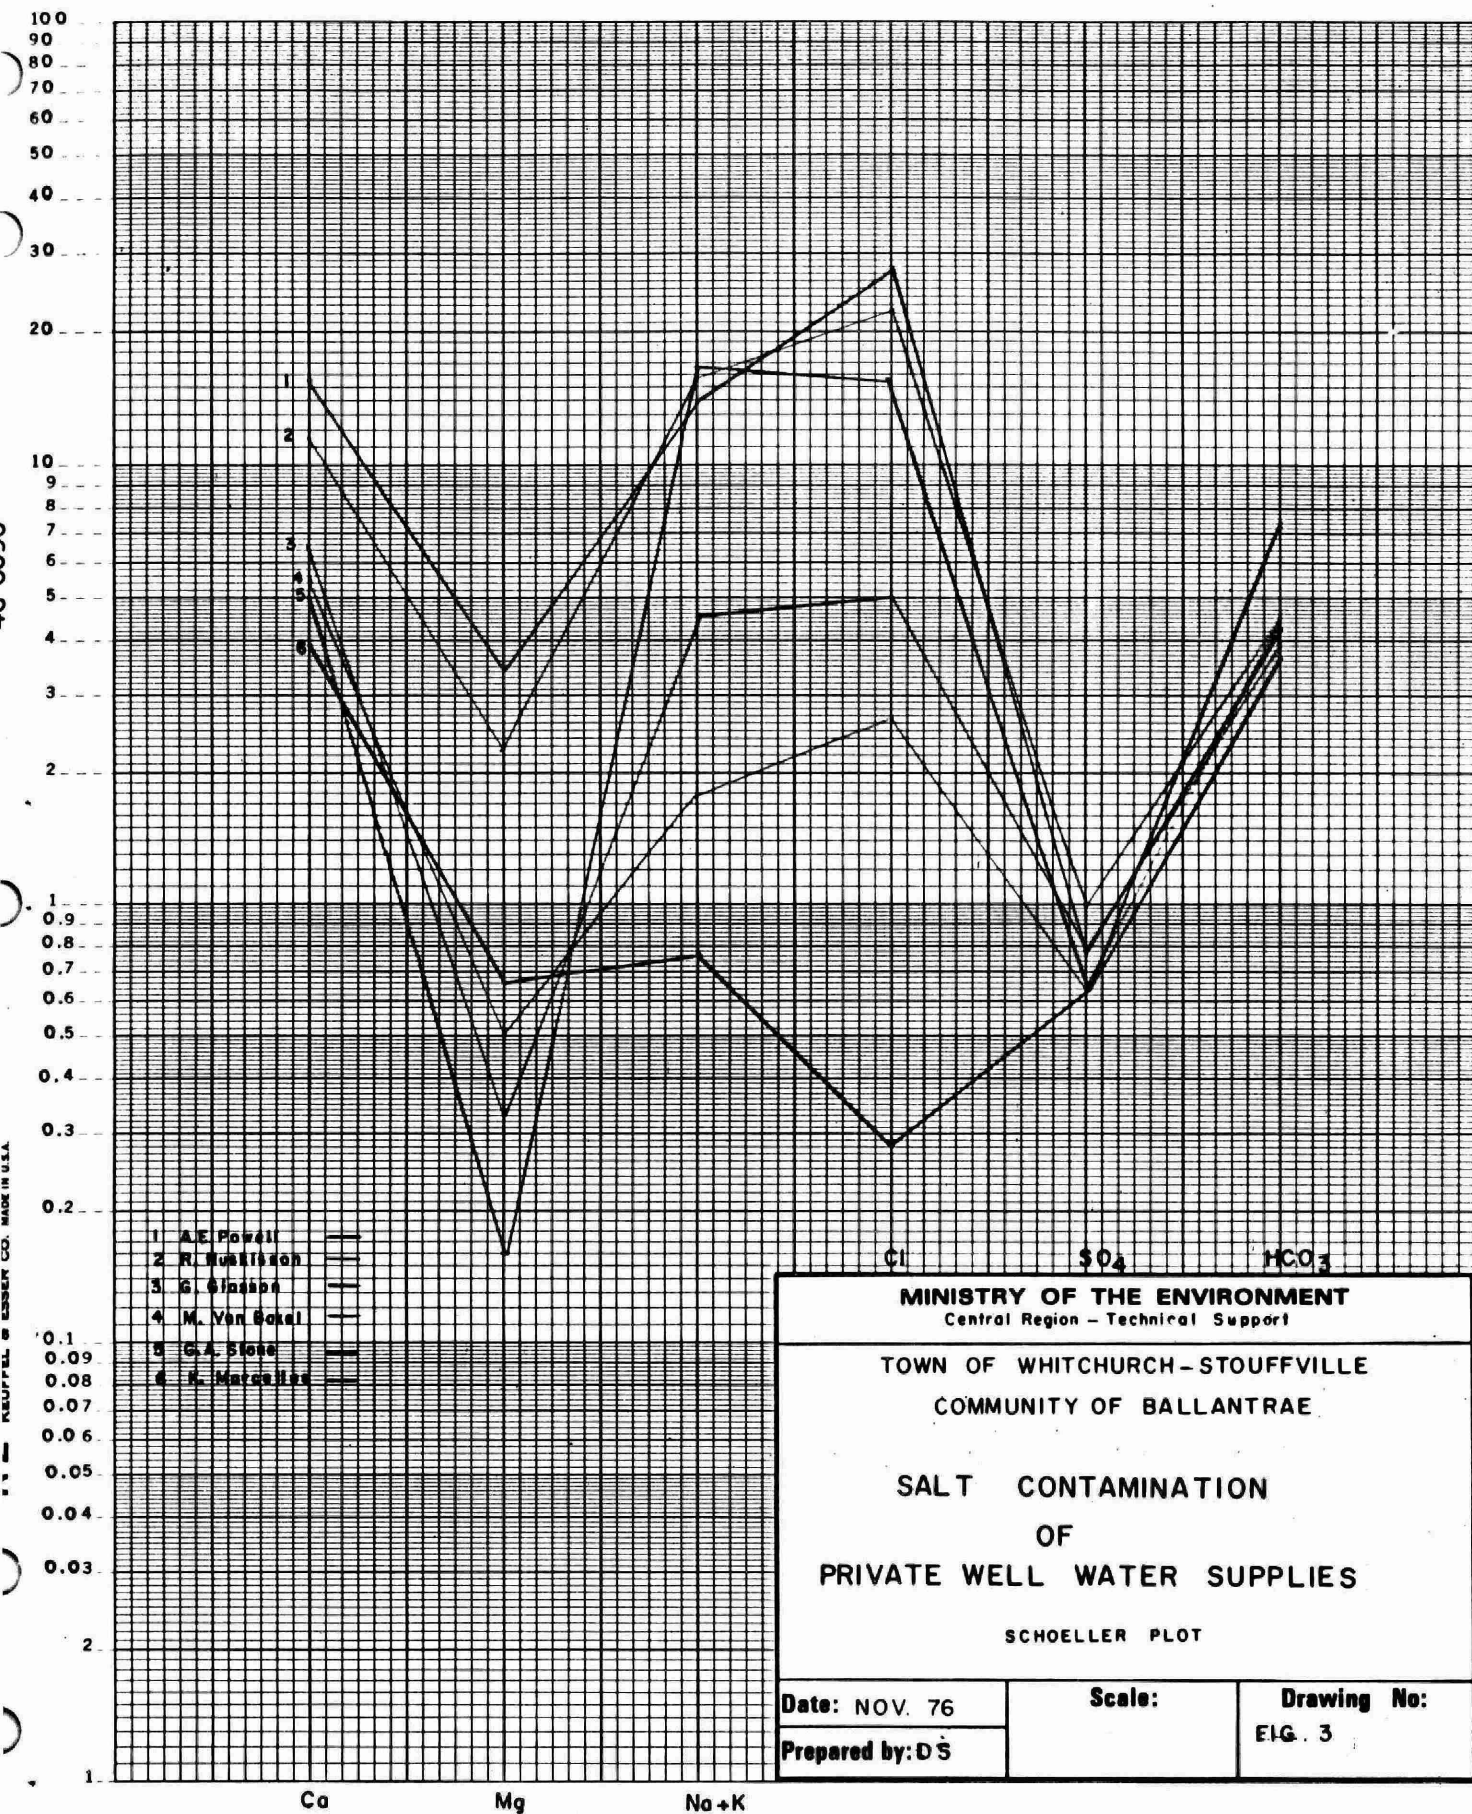
FIG. 4

From the plots (Fig.3, 4 and 5) it can be seen that 4 distinct patterns exist. Two patterns exist in the upper aquifer with unique patterns being found in the middle and lower aquifers. In Figure 5 some time perspective is given to the data.

From the Schoeller plots, Figures 3 and 5, it can be seen that the Marcellus well has the lowest sodium and chloride levels and probably represents background quality. The pattern for this well does not appear to match other wells in the area. If, however, the sodium (i.e. sodium plus potassium) and chloride points are observed on the Wedley and Van Bakel wells, it will be observed that the sodium point is gradually increasing with the chloride point increasing at a greater rate. Thus the Marcellus, Wedley and Van Bakel plots show the transition from background quality to the altered quality. Plots 1, 2, 3 and 5 on Figure 3 show an increasing distortion in the sodium and chloride areas.

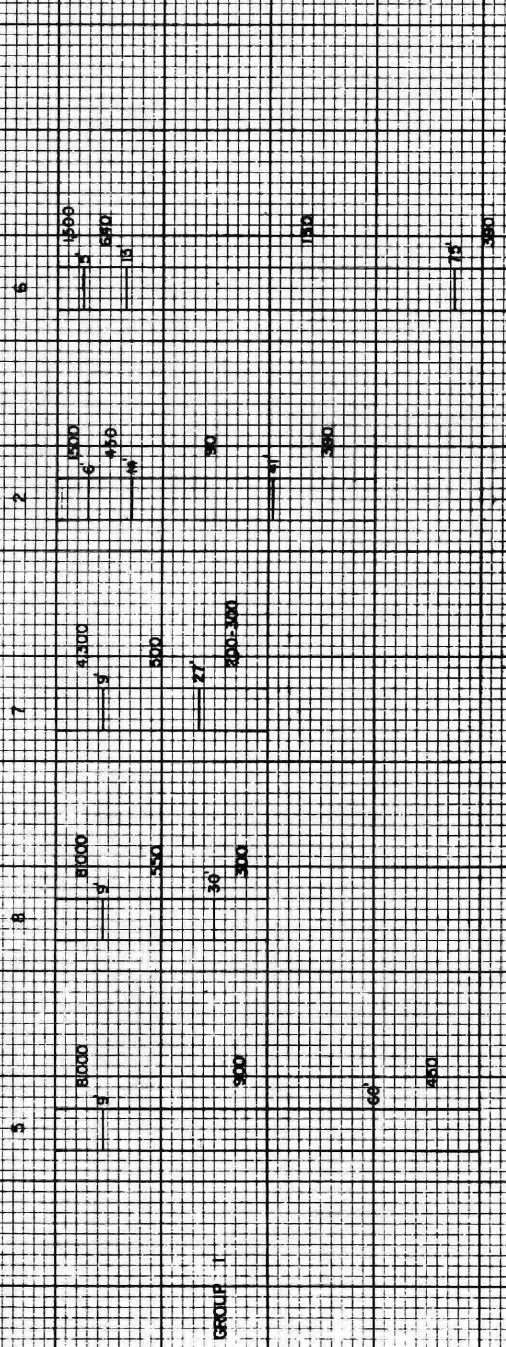
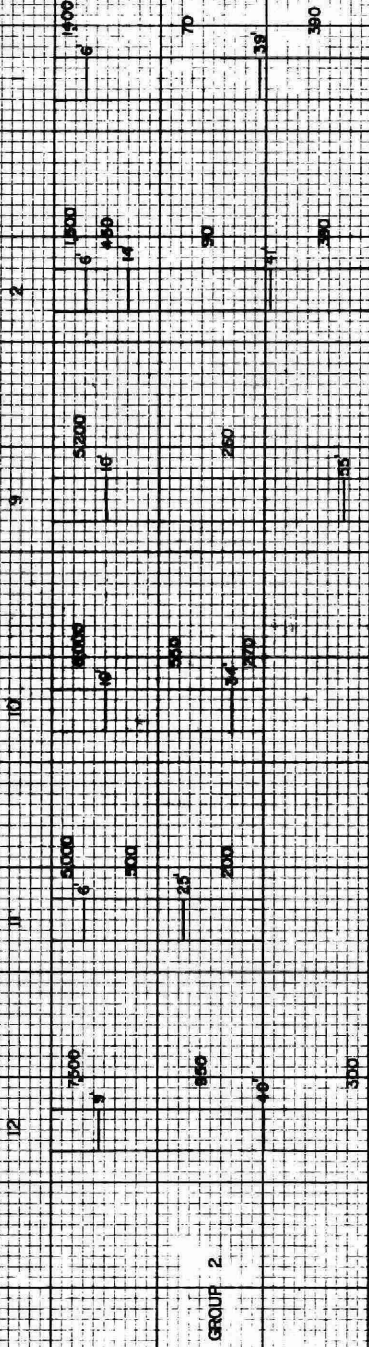
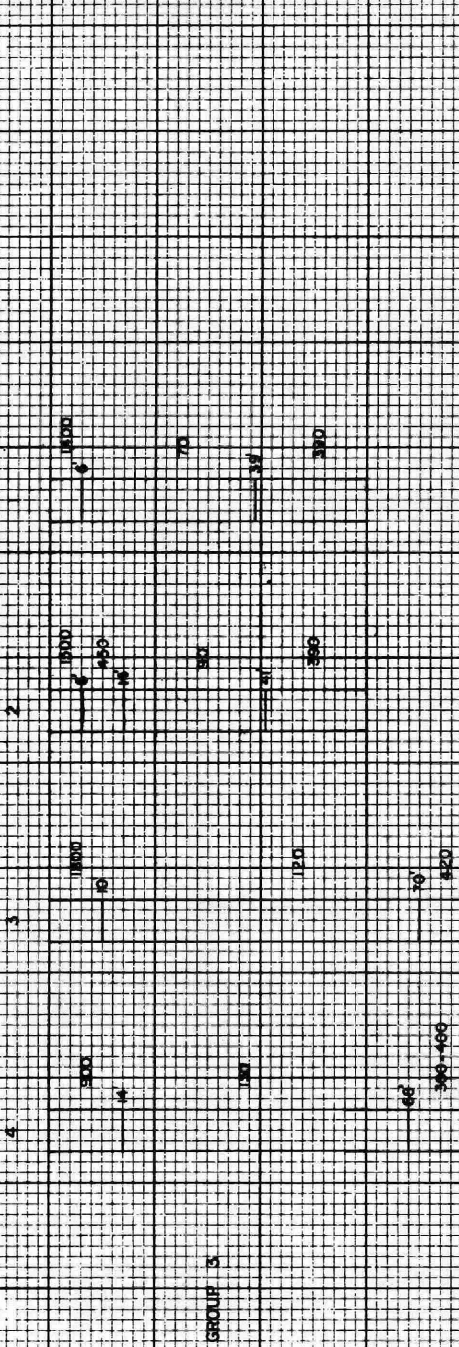
FIGURE 2

The soundings adjacent to Highway 48 (VES 1, 2, 3, 4 & 6) all show low values of resistivity ranging from 70-150 ohm/feet for the formation below the water table. In all the other soundings the resistivity of this formation is higher. It may be noted that the very low values of 70 ohm/ft and 90 ohm/feet in VES 1 and 2 occur near the property of Mr. Muskisson whose well has been severely contaminated.

In conclusion, it may be stated that the low values of resistivity occur only in the immediate vicinity of the highway. It is likely that these low values are due to a deterioration of ground water quality as a result of road salting operations along Highway 48 at Ballantrae. The contaminated wells are located near the highway and obtain water from the portion of the aquifer contaminated with road salt.
